M&R Hydraulics have been providing hydraulic solutions & support services for a multitude of clients' for over 30 years.

## Case Study 3 – Improved Oil Cleanliness

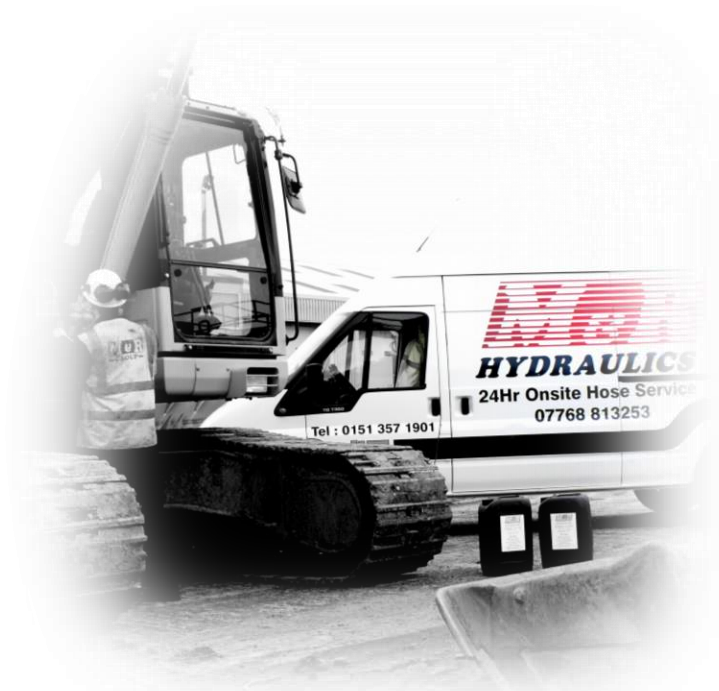
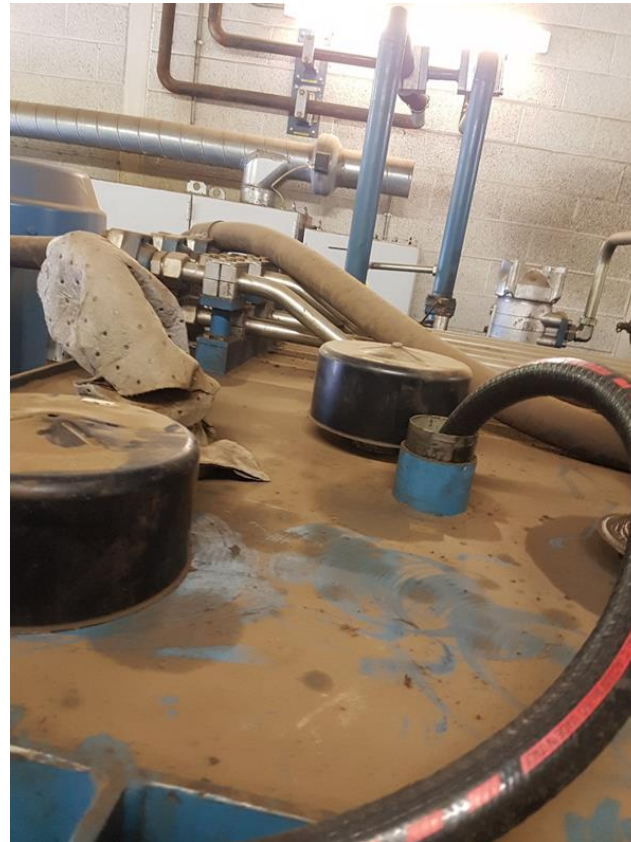
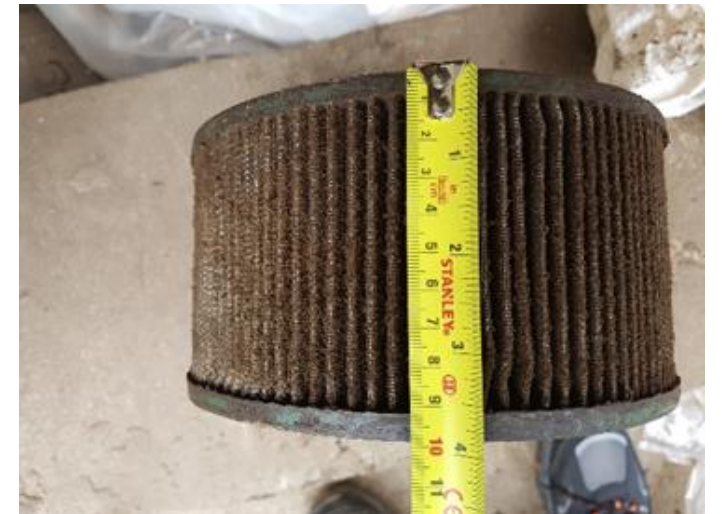
Breathers x 8 identified as a major cause of dirt ingress

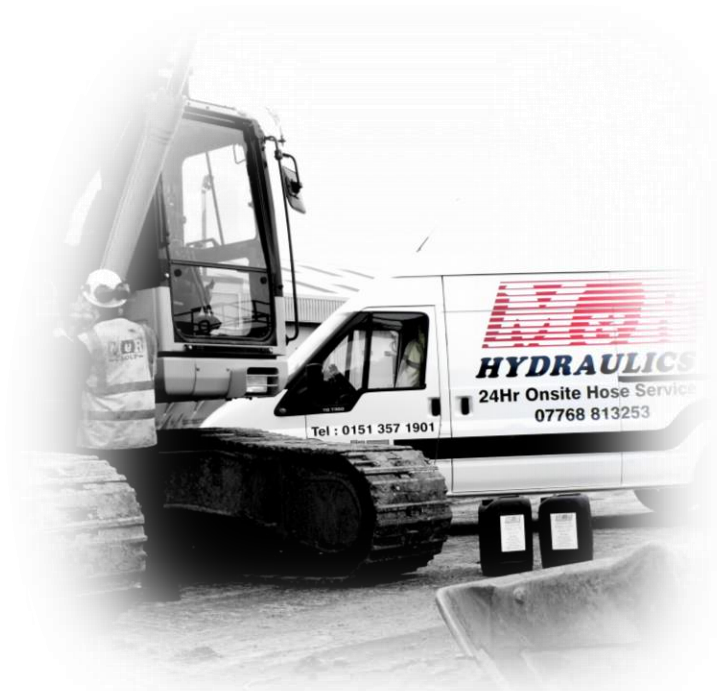
External analysis confirmed lower ISO code now a readable 19/17/13  
Patch results matched the above ISO code. Analysis water PPM fell within customer parameters

**No. 1 Red Oil** The level of observation of the test membrane suggests the overall contamination is within recommended limits for a hydraulic system, being estimated at **0.5mg / 100ml oil & ISO 18/17/13 & NAS 8**.  
Contaminants seen include micron sized carbon deposits, fibre and miscellaneous unsorted particle.

**No. 2 Black Oil** The level of observation of the test membrane suggests the overall contamination is outside recommended limits for a hydraulic system, being estimated at **0.4mg / 100ml oil & ISO 18/17/13 & NAS 8**.  
Contaminants seen include micron sized carbon deposits, fibre and miscellaneous unsorted particle.
