White Grease or Water in **Hydraulic Oil?**

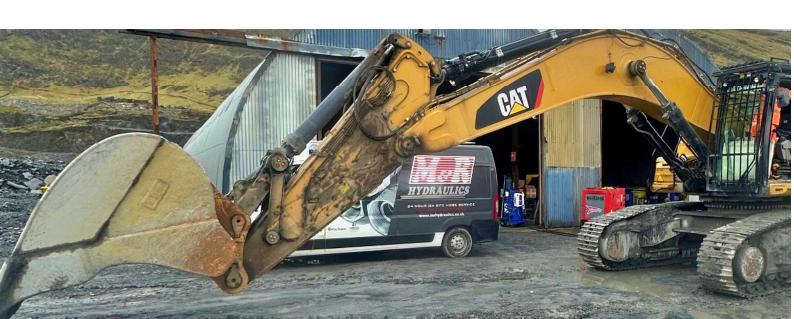
The white grease appearance on the underside of this filler cap is not grease but a classic sign of water contaminated hydraulic oil & its removal is vital before irreversible damage is done, leading to expensive machine repairs.

The hydraulic filler tank on this Cat Excavator had an unexpected ingress of water which emulsified the oil & rendered the equipment useless and the job stopped.

In this instance, a Hy-Pro Filtration mobile Vacuum Dehydrator was deployed to remove the emulsified water from the hydraulic oil. Within 48hrs, the hydraulic oil was transformed into its original clean & dry condition.

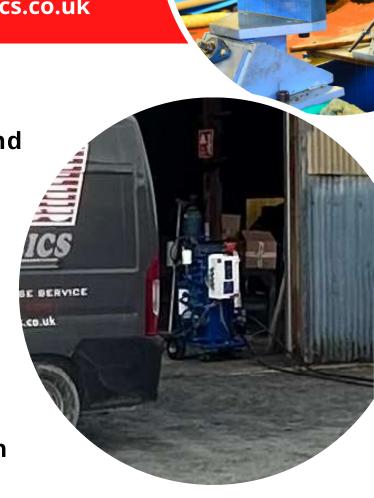
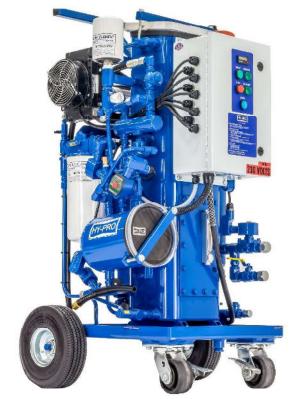
So, if you encounter a mayo like substance or notice a milky appearance to your hydraulic oil, don't delay in reaching out to M&R Hydraulics for assistance & avoid the unnecessary oil wastage or worse still, mechanical failures related to water in hydraulic oil.
